Assessment of Dam Safety

Coal Combustion Surface Impoundments (Task 3)

Final Report

Duke Energy
Buck Steam Station
Spencer, North Carolina

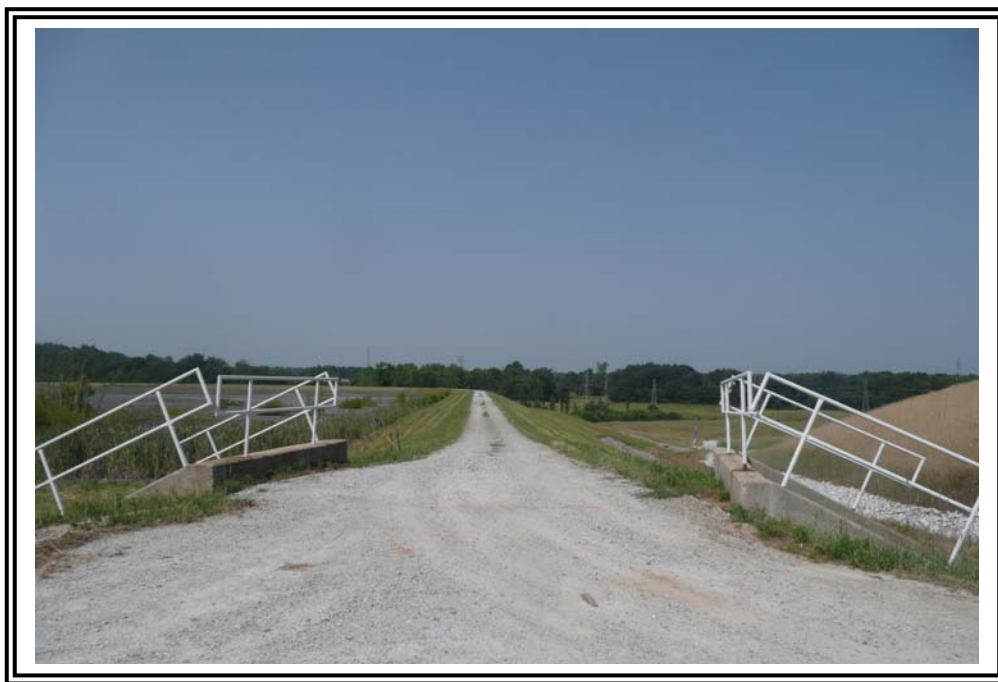
In general, the alignment of the new dike crest does not show signs of change in its horizontal alignment. No evidence of prior releases, failures or patchwork on was observed at the time of the site visit. Photos 2 and 23 show the north and west portions of the new dike crest alignment, respectively.

New Dike crest looking southwest (from North Abutment).

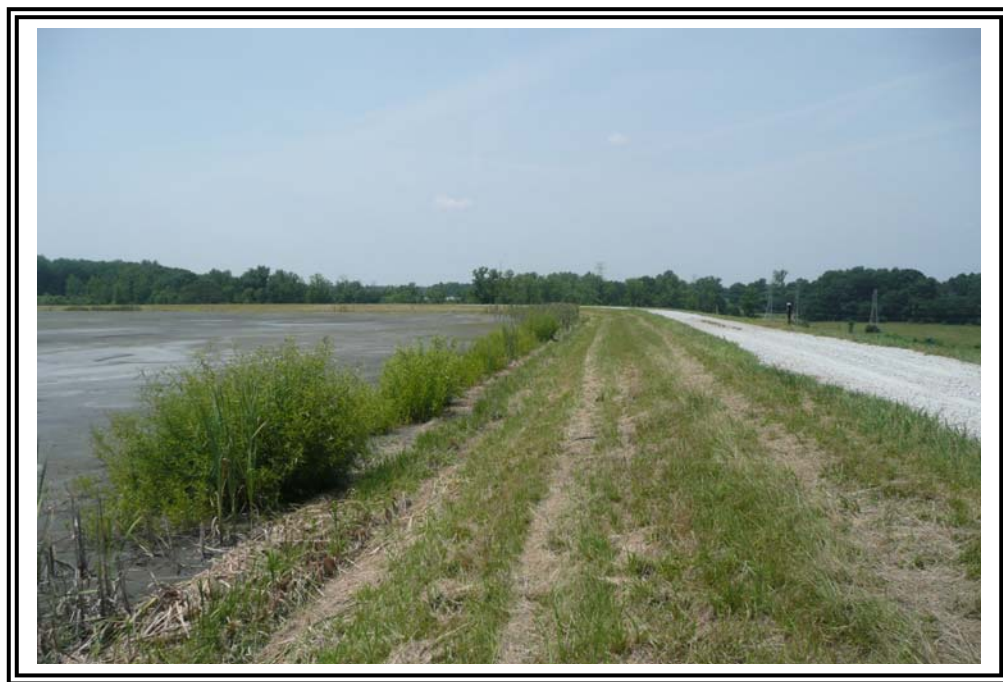
4

New Dike crest and upstream slope looking southwest.

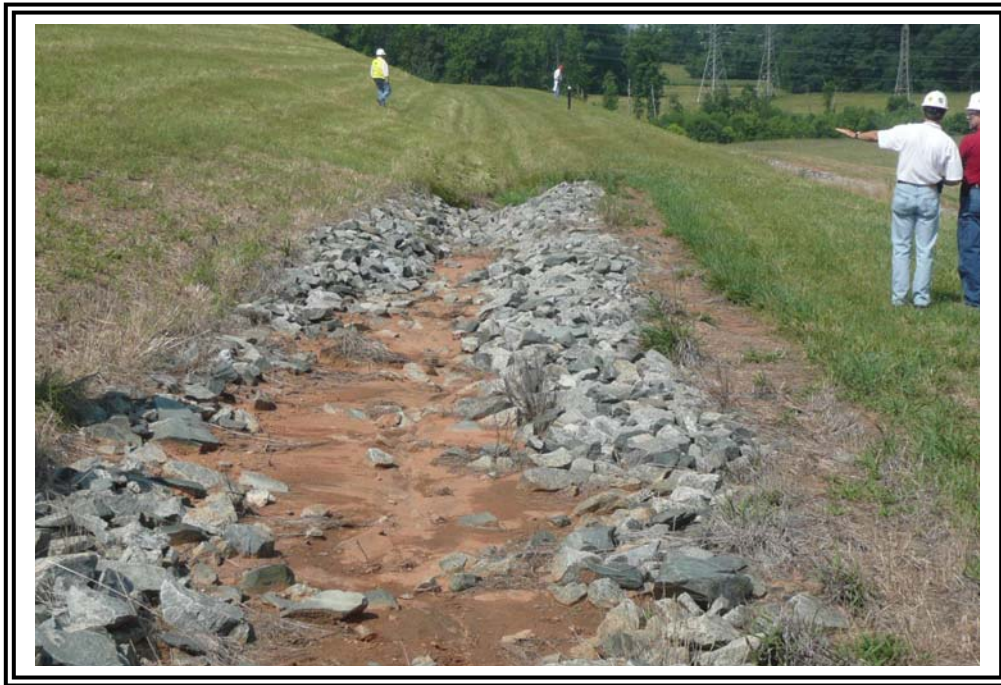
7

Drainage swale at north end of upper bench clogged with silt.

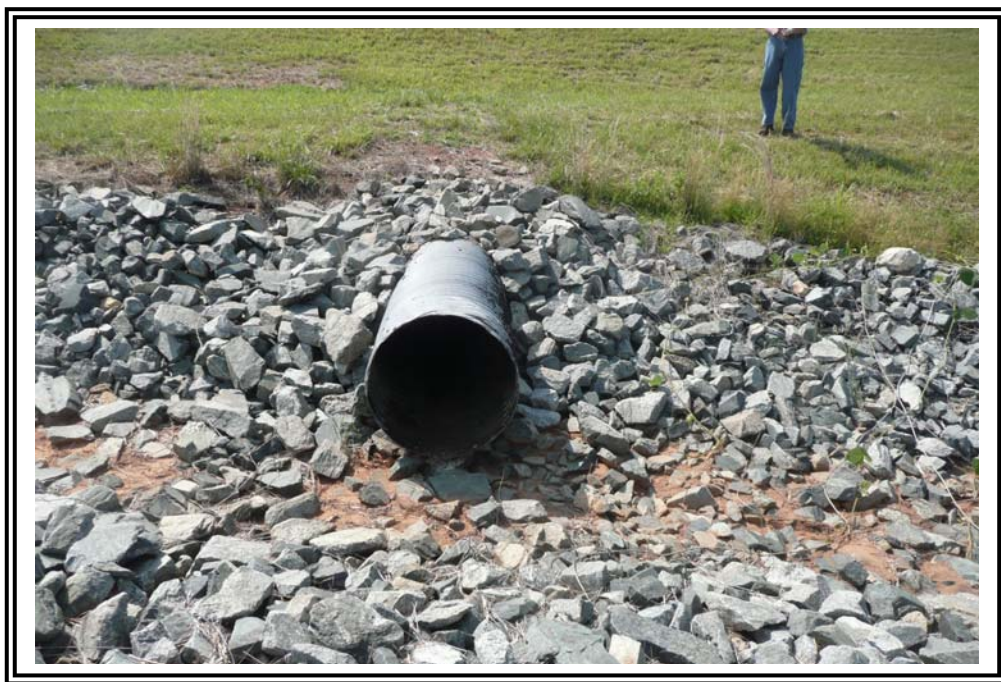
8

Upper bench drainage swale culvert discharging into toe swale.

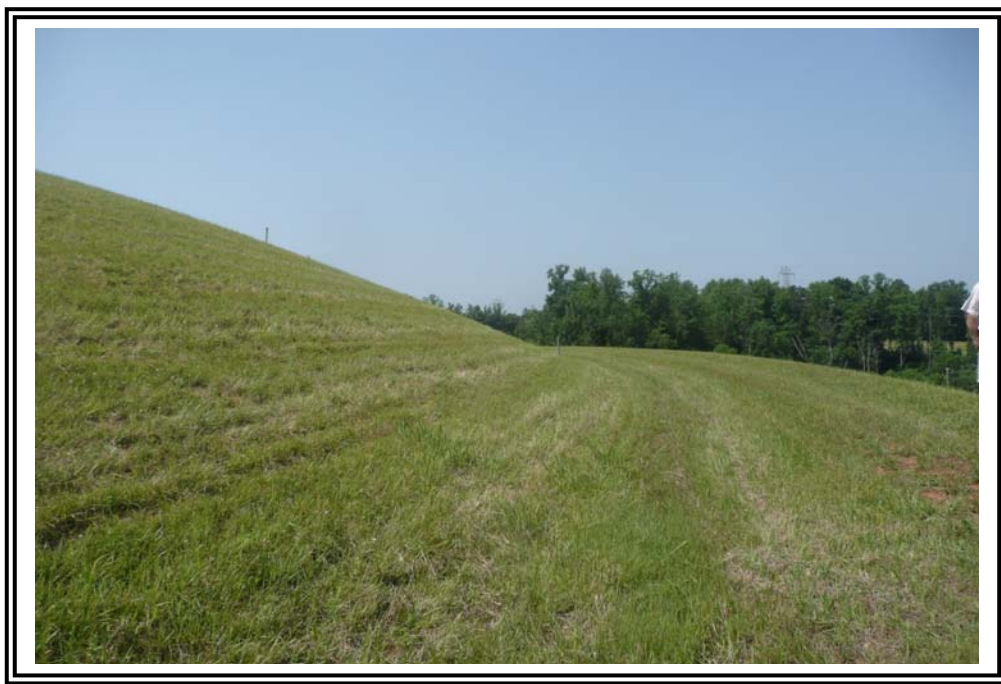
The downstream slope was reasonably uniformly graded, and covered with appropriate grass vegetation. There are occasional areas where the grass is sparse, such as those areas shown in Photos 10 and 13.

Downstream Slope at Upper Bench of New Dike looking southwest. Note occasional sparse grass cover.

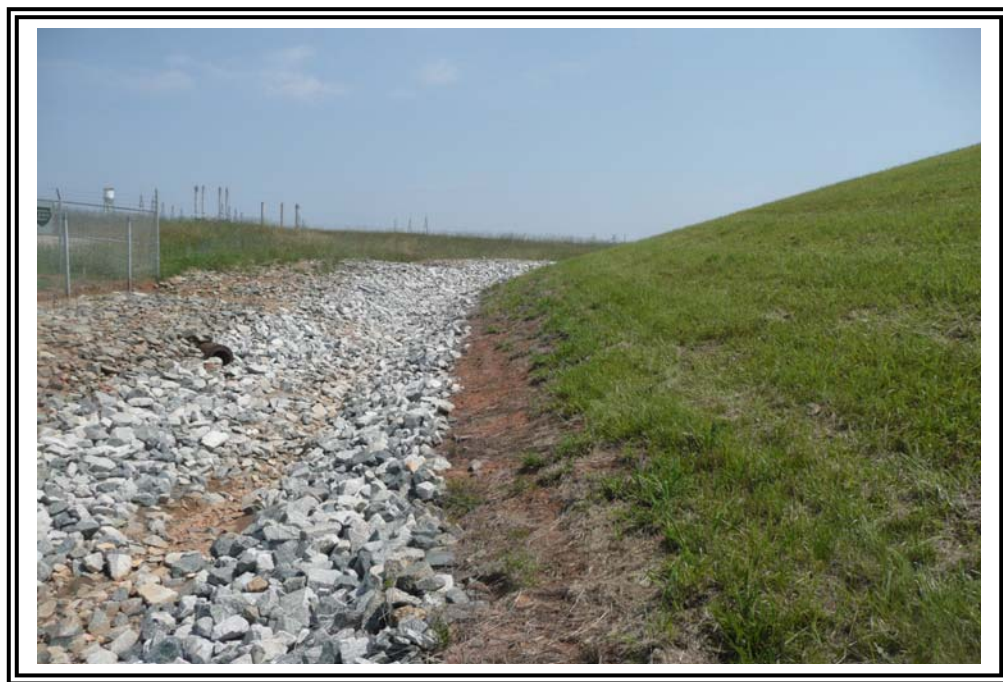
16

Toe swale of New Dike looking north. Note drainage pipe entering drainage swale from across access road to new combined cycle plant site. Sparse vegetation along rip rap edge likely from herbicide use to control weeds in the rip rap.

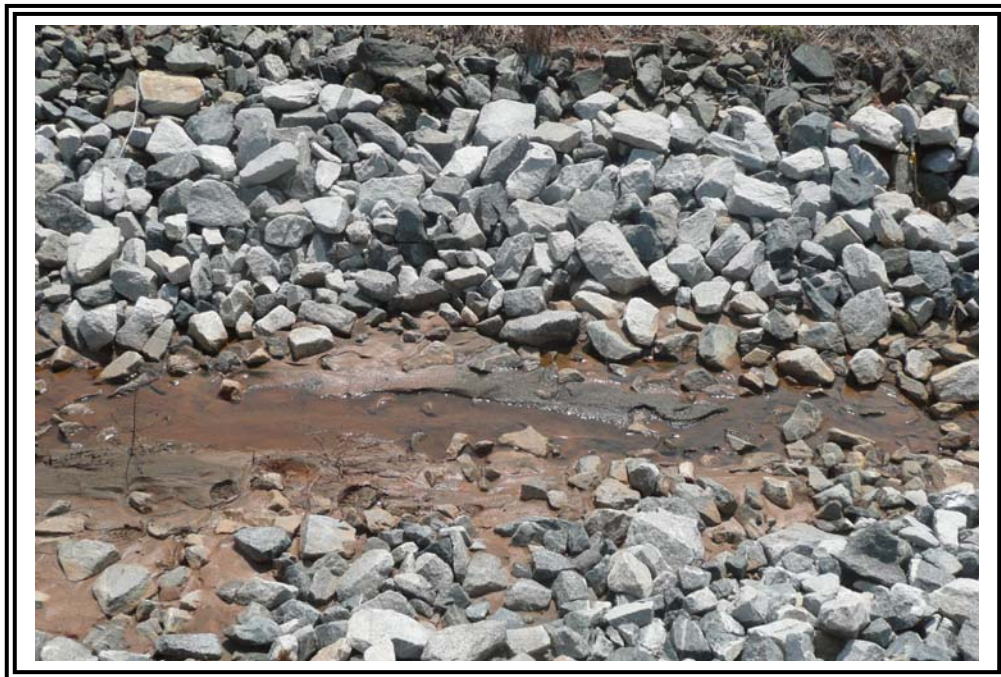
18

Closeup of toe drain seepage at New Dike. Water was flowing clear. Reportedly Duke Energy is in the process of discussing installation of a seepage monitoring system with an outside consultant.

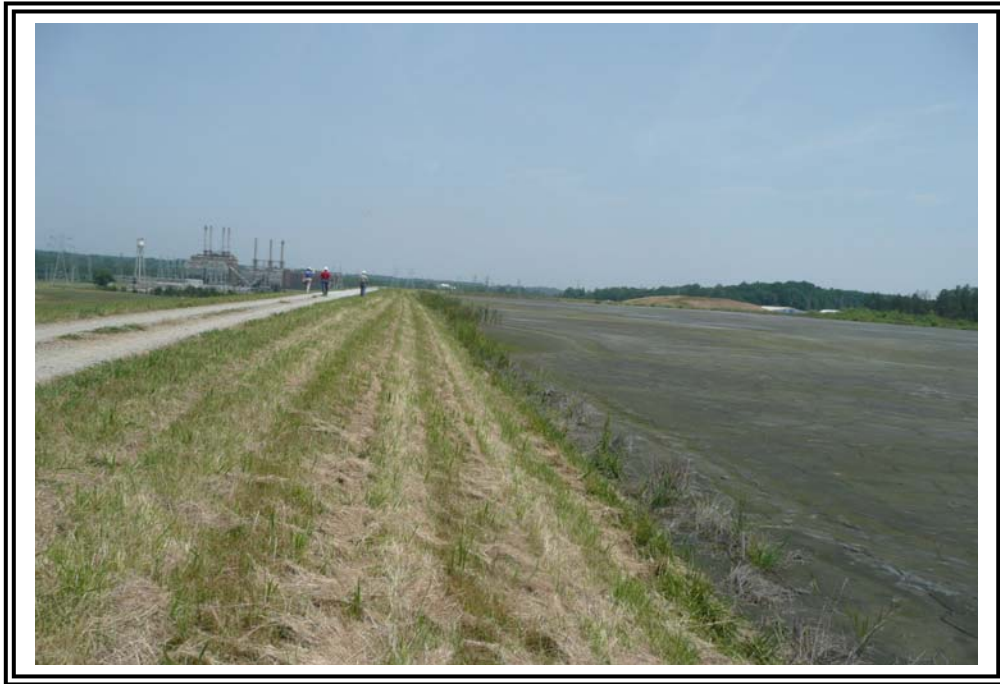
23

Upstream slope and crest alignment of west portion of New Dike, looking north.

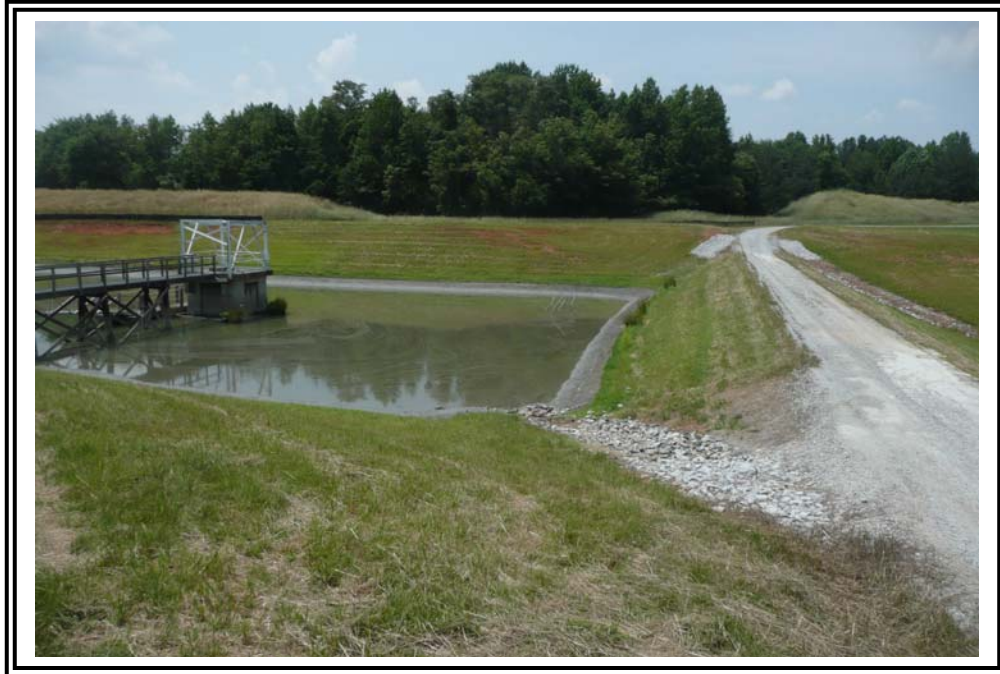
25

The outlet control structure controls the water level in Basin 1 via stop logs in an overflow weir. The water then discharges through a 36-inch diameter concrete pipe into Basin 2. As can be seen in Photo 25, the stop log system experiences significant leakage resulting in the lowering of water in Basin 1 below the normal decant elevation when ash is not being actively sluiced into Basin 1. During our visit, the Buck Steam Station was not generating power so no ash was being sluiced into Basin 1.

Basin 1 Outlet Tower.

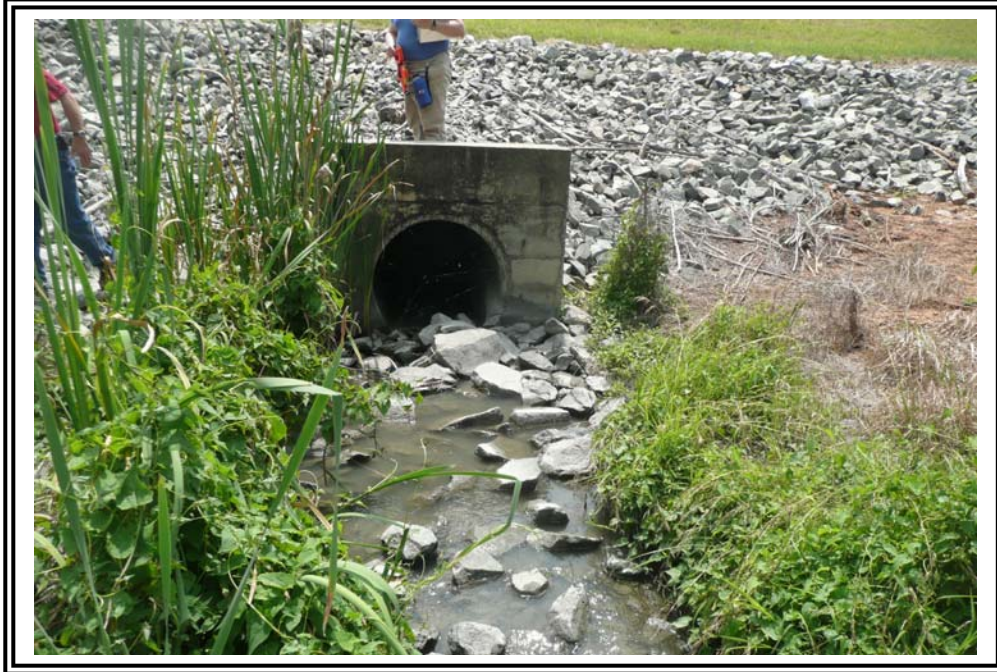
Photos 26 and 27 show the downstream end of the outlet pipe, and the discharge channel between the outlet pipe and Basin 2. Seepage was noted adjacent to the downstream end of the outlet pipe headwall. This seepage flow appeared clear at the time of the site visit.

Downstream end of Basin 1 outlet pipe.

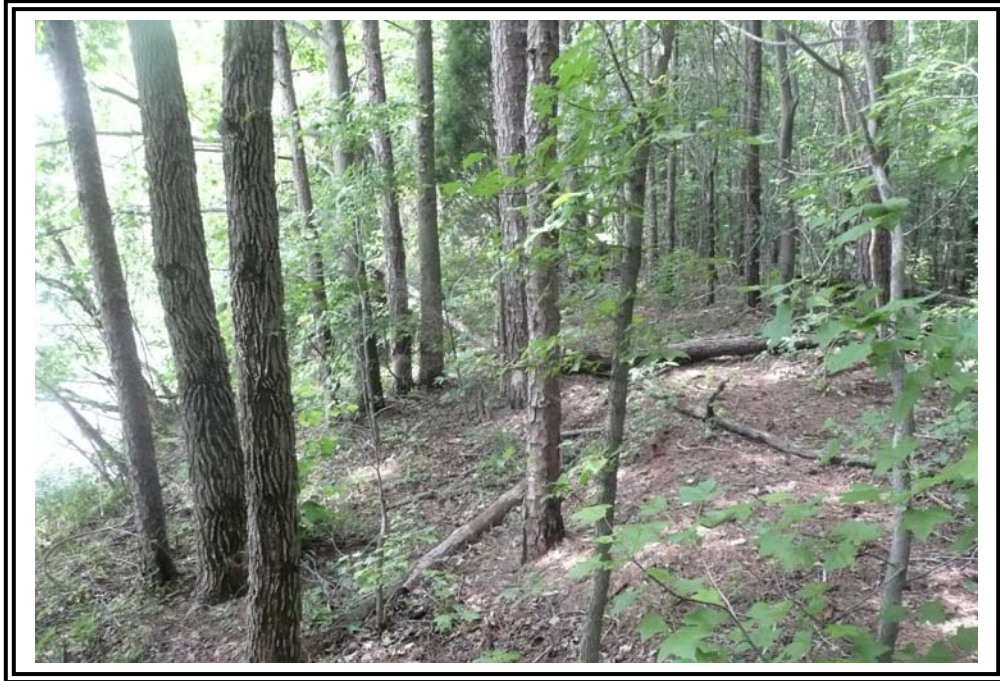
Although difficult to distinguish in the photograph, Photo 34 is typical of the conditions of the second portion of the main dike.

Main Dike extended all the way to the emergency spillway. Overgrown portion not impounding water during normal pool operations.

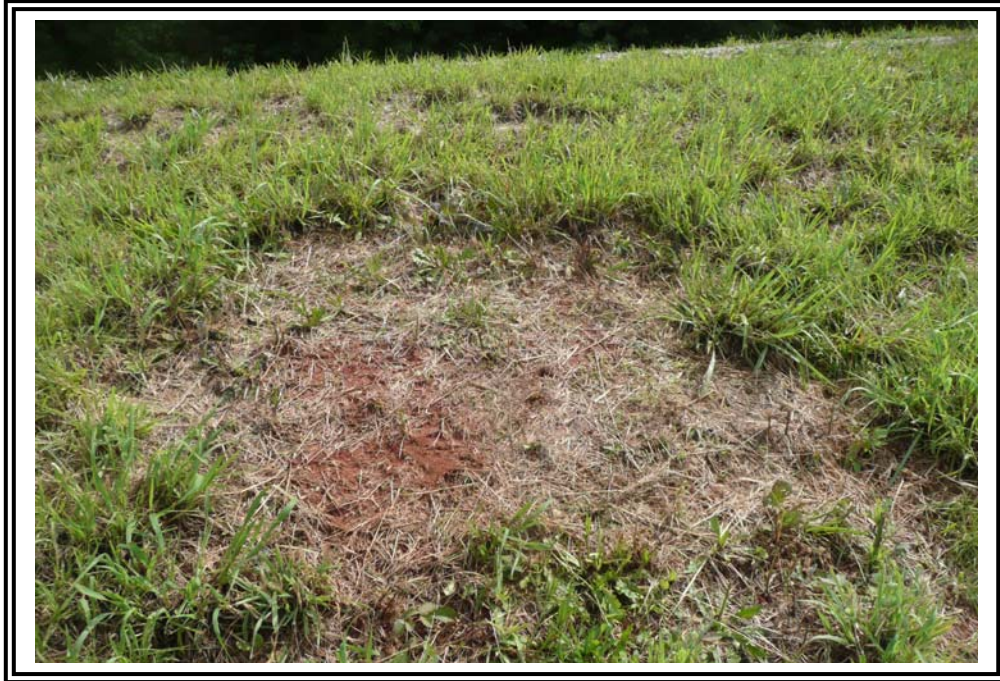
36

Close up of poor vegetation cover area.

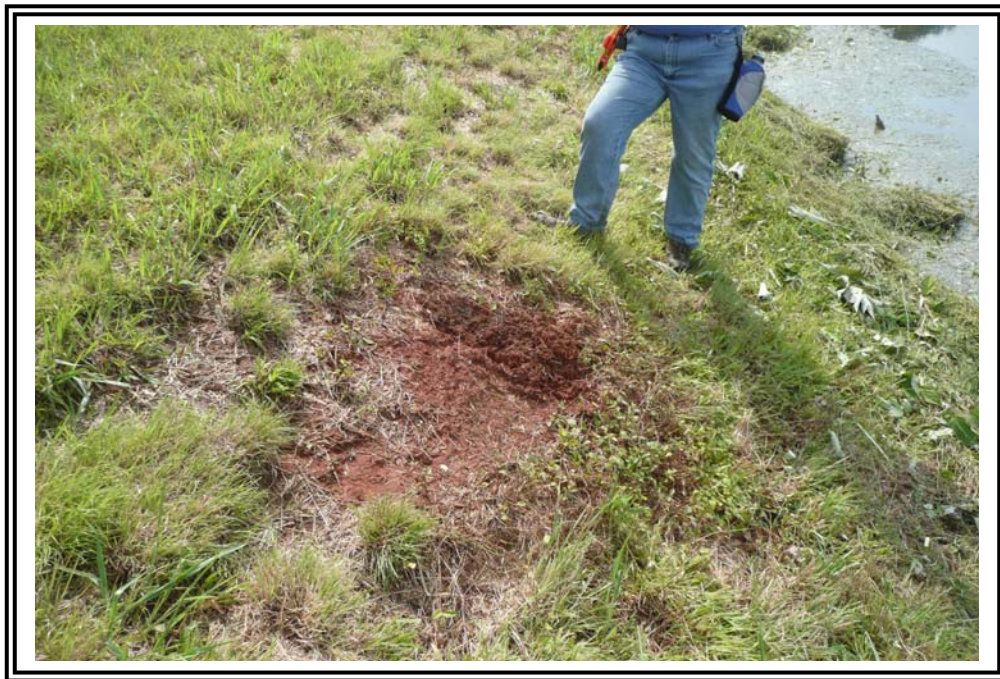
37

Close up of animal disturbance (possibly turtle nest).

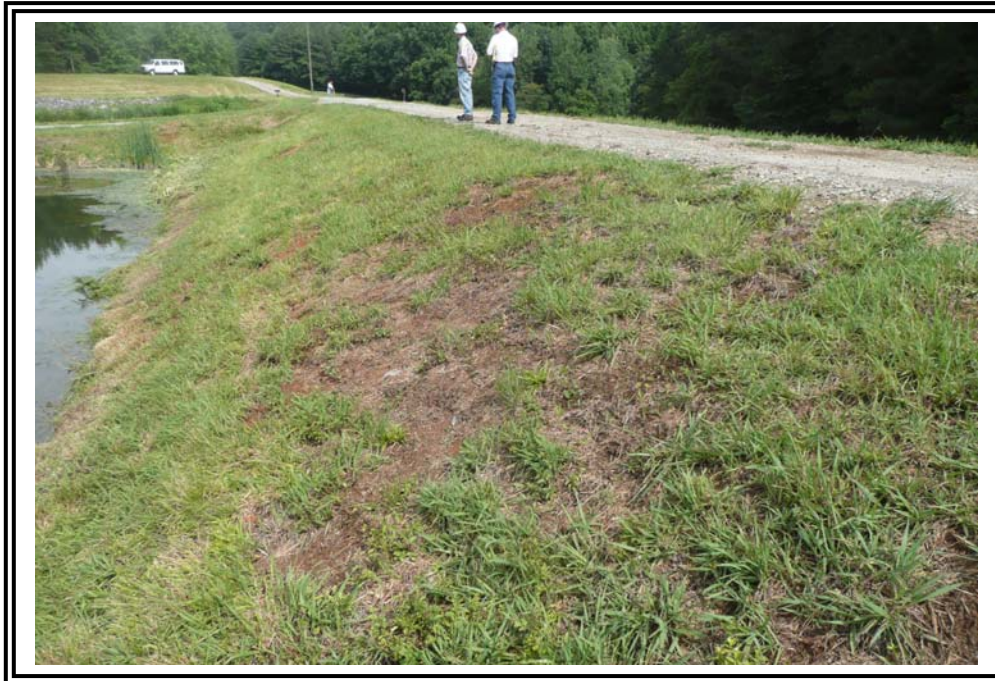
38

Close up of poor vegetation cover area.

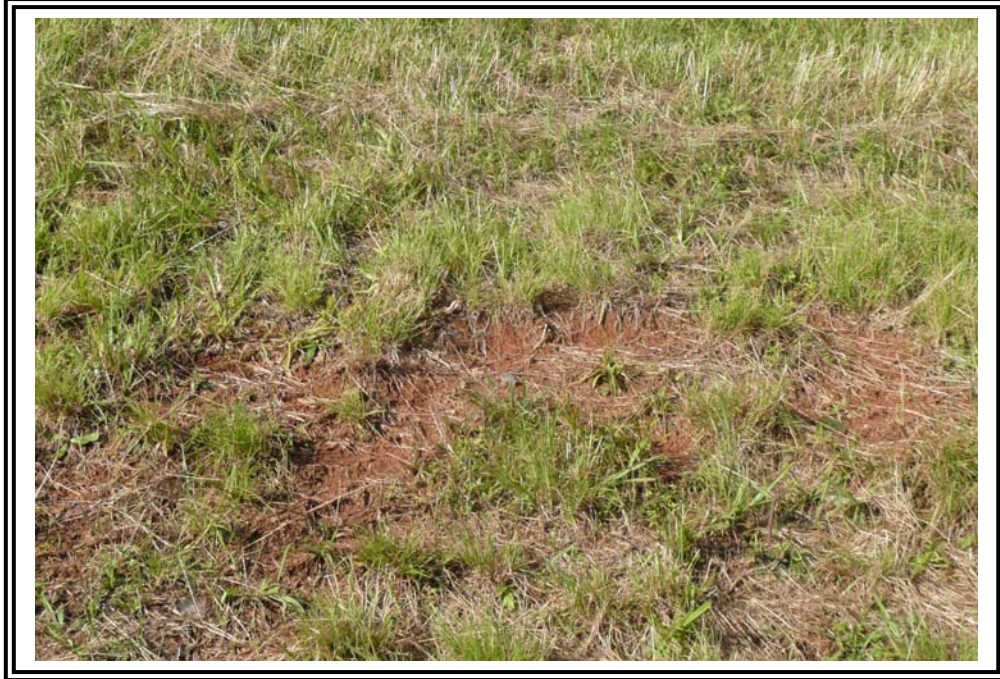
42

Close up of poor vegetation cover on downstream slope of Main Dike.

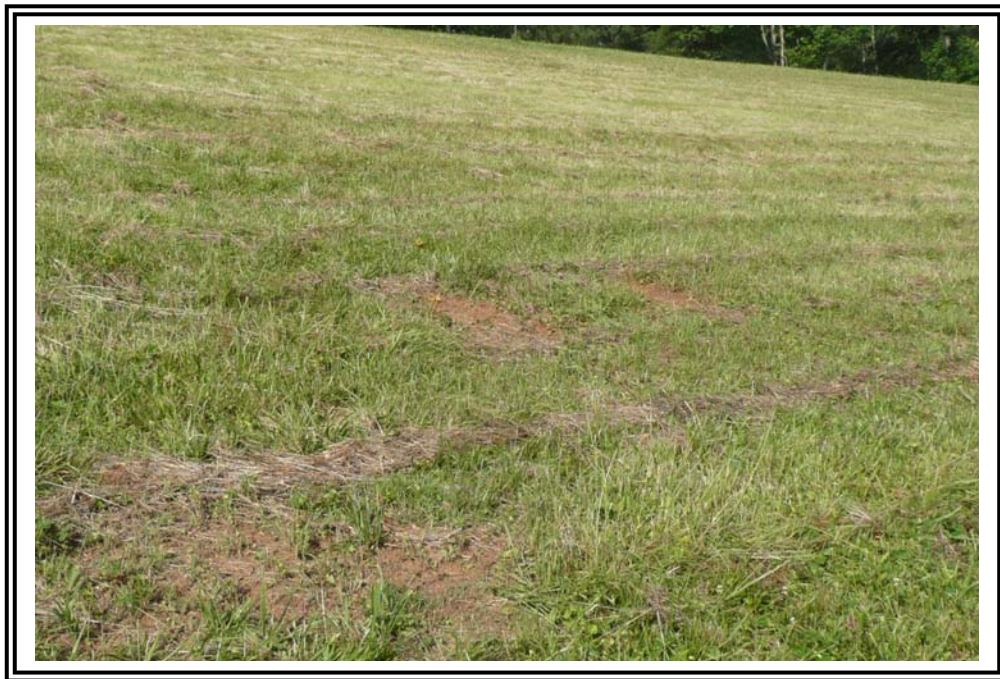
45

Close-up of sparse vegetation cover.

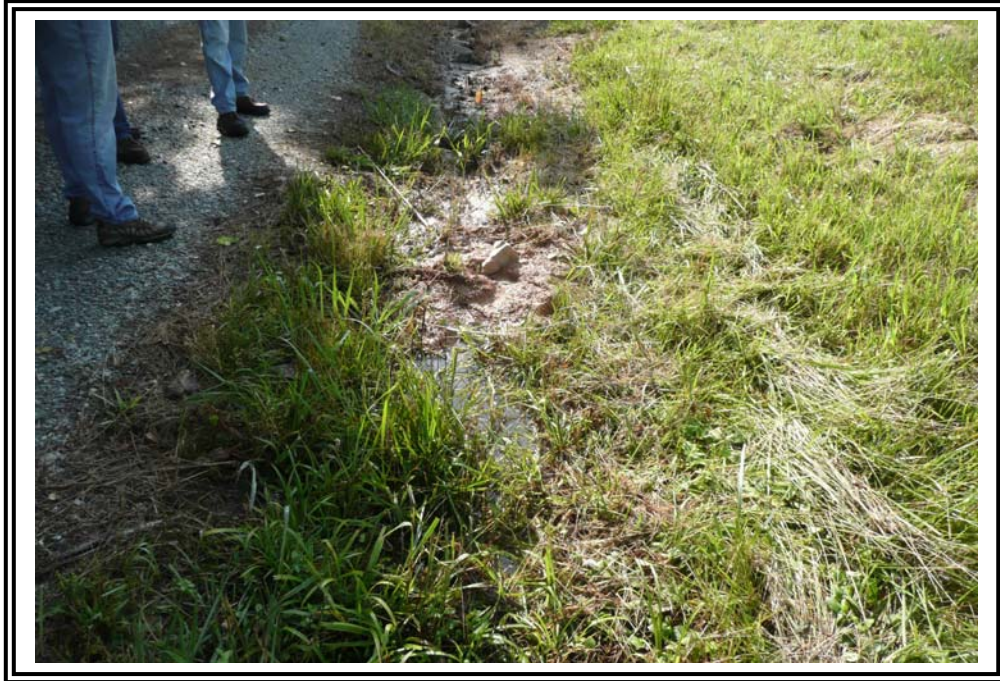
46

Clogged groin drainage swale on west end of Main Dike. Sediment appeared to include bentonite chips, possible runoff from poorly cleaned up drilling at “new” monitoring wells.

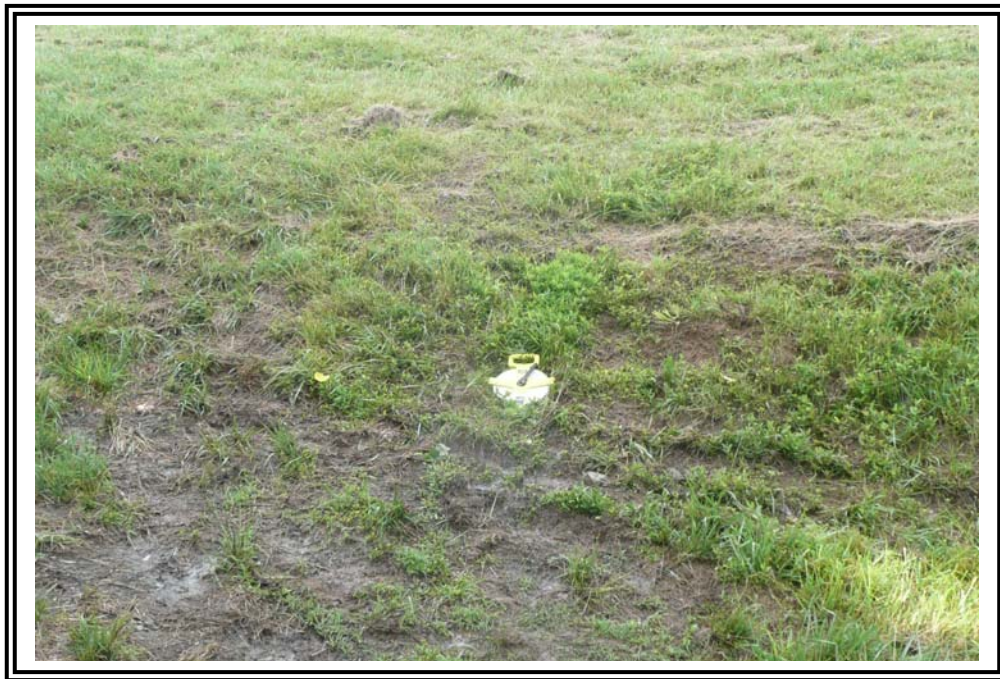
47

Sparse vegetation at toe of Main Dike near the outlet structure.

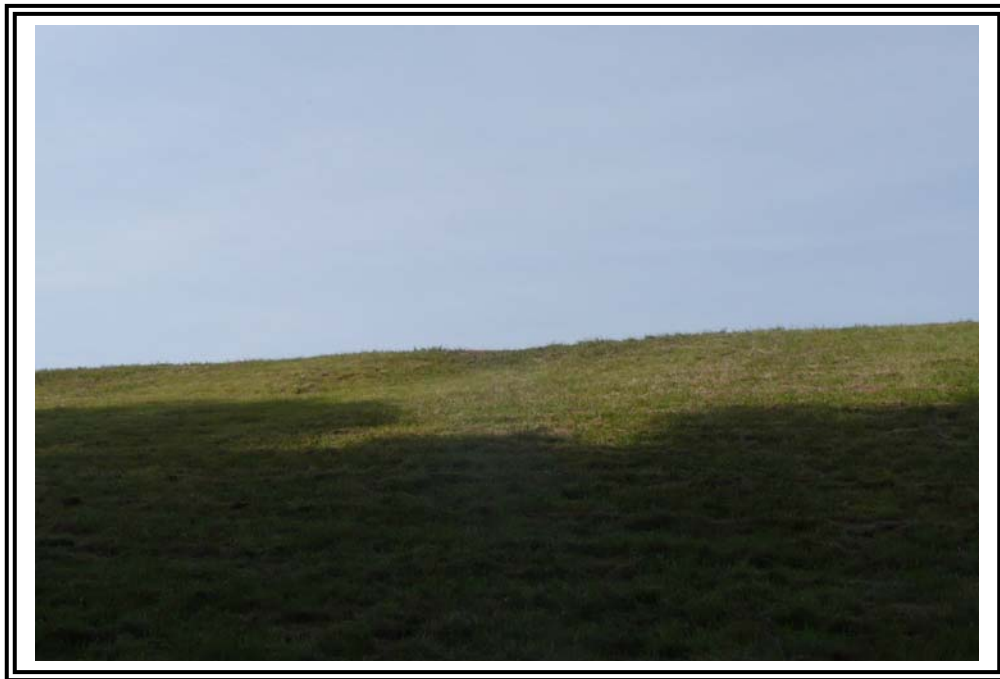
49

Low spot at crest, as seen from toe of Main Dike, location is adjacent to Basin 3.

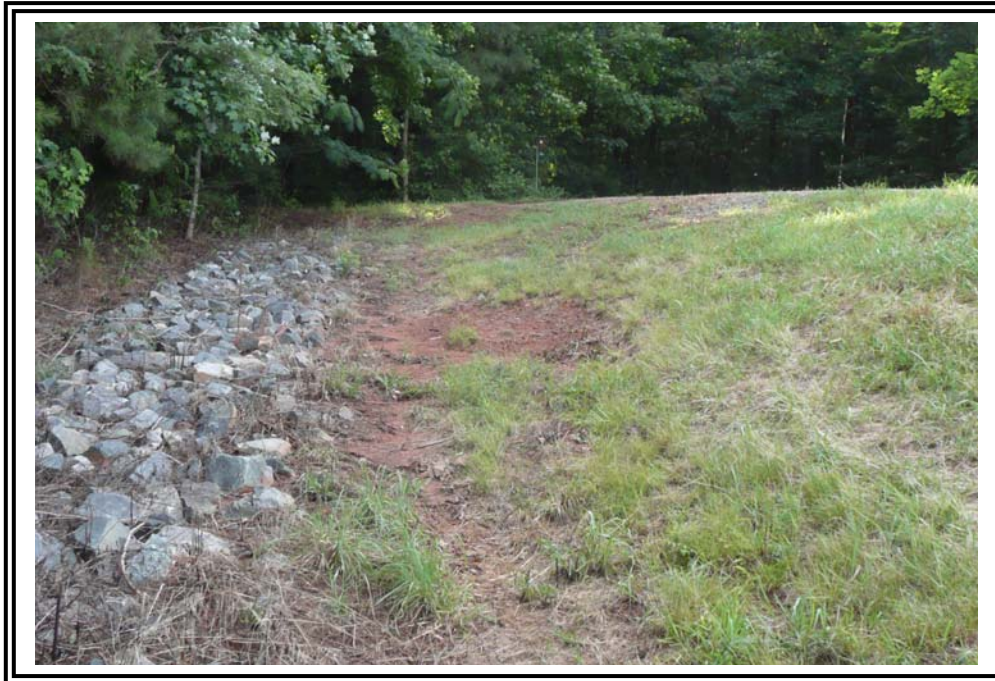
50

Sparse vegetation on downstream slope at east end of maintained Main Dike, looking east.

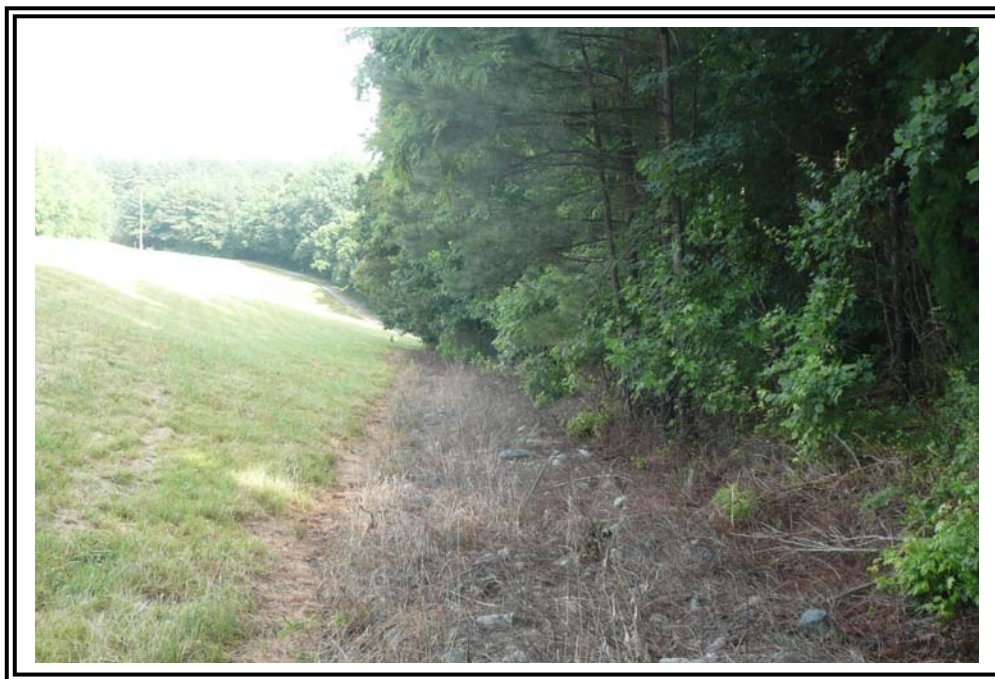
51

Herbicide treated vegetation in groin swale at the east end of Main Dike.

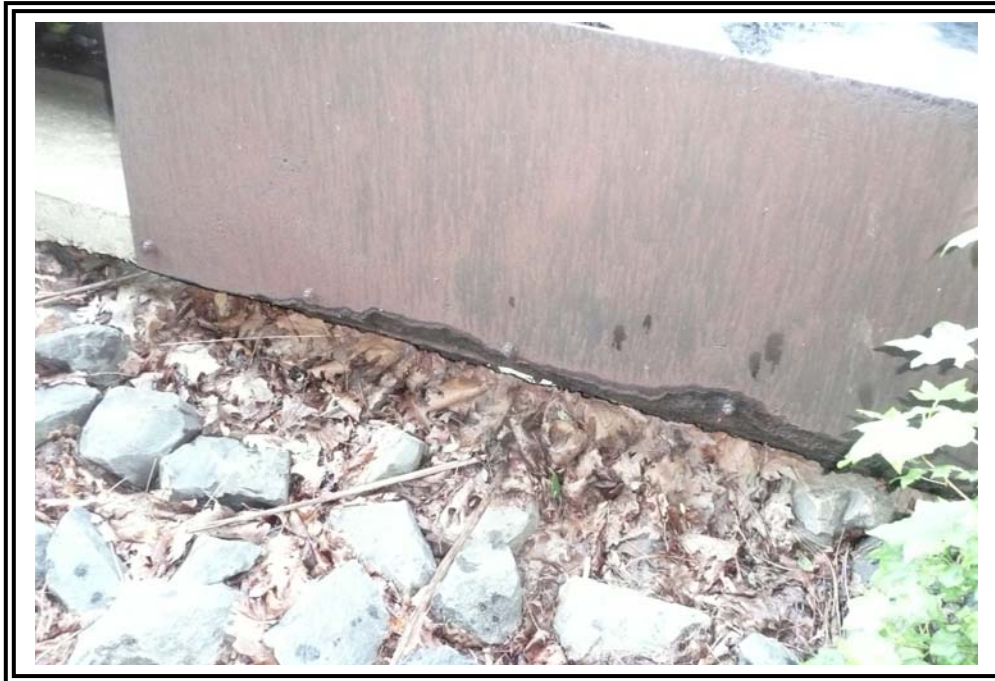
58

Slight undermining of concrete discharge channel at outlet structure.
Baffles in place to control splash out of channel during high flows.

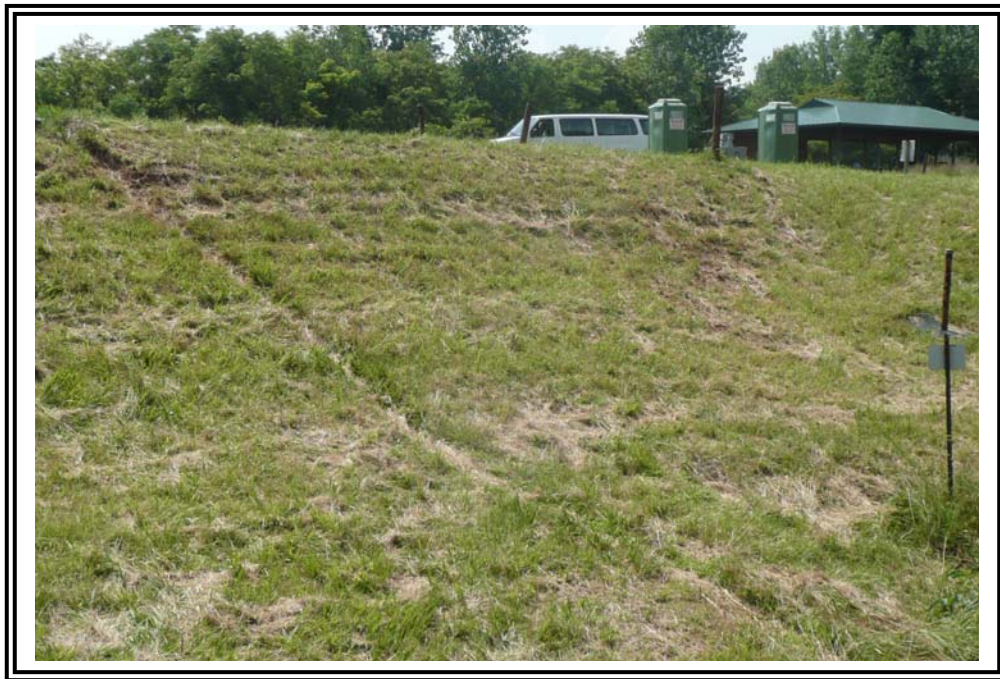
65

Animal trail on downstream slope of Basin 2 to Basin 3 outlet dam.

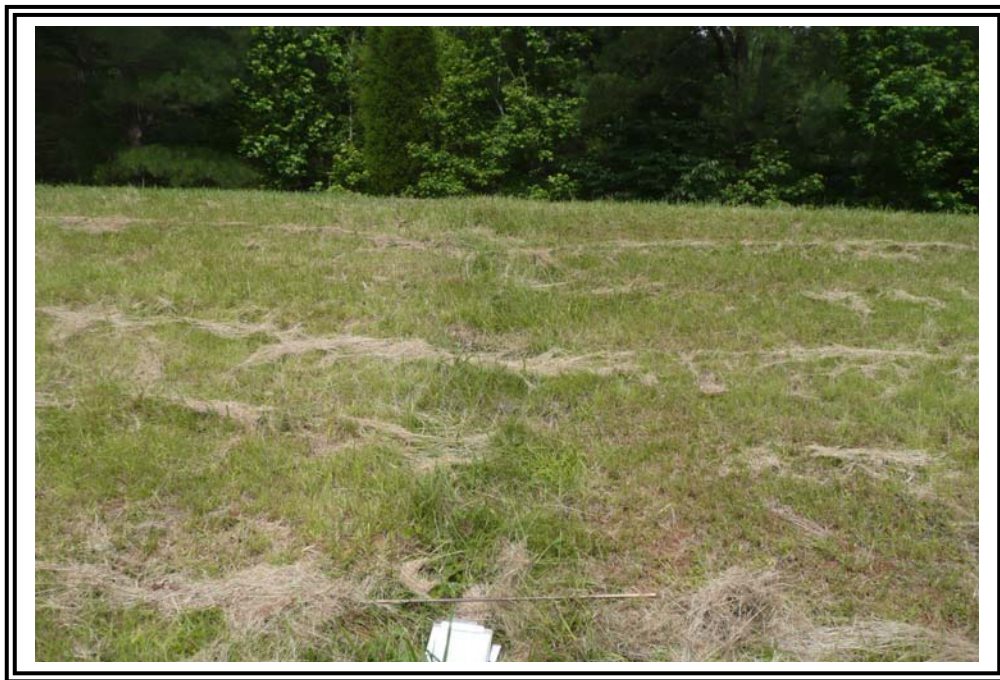
72

Erosion swale on downstream slope of Diverter Dike.

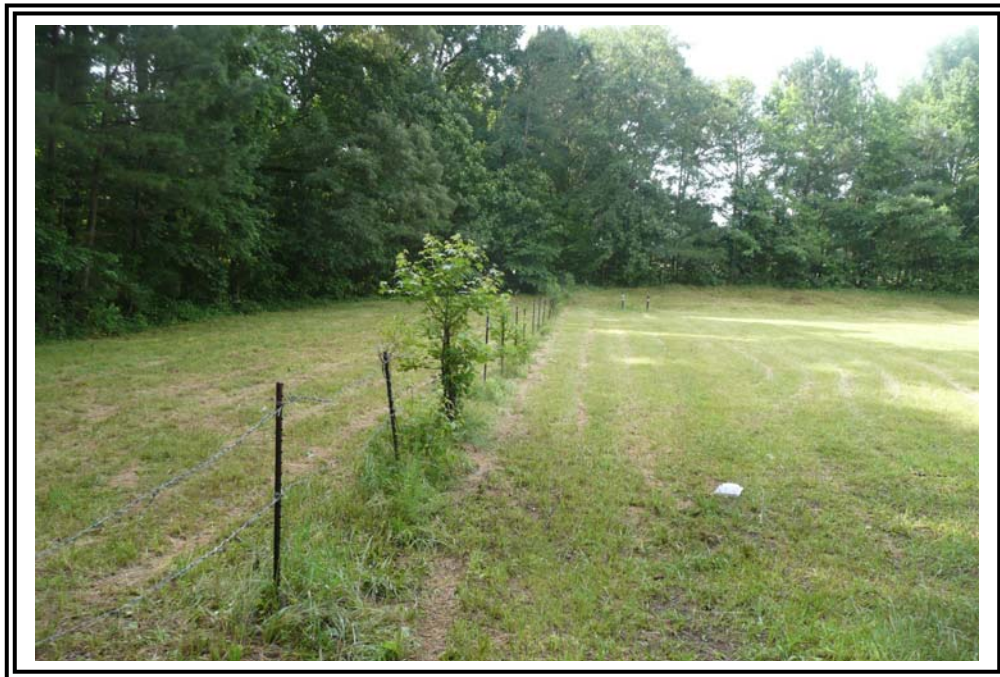
Fence across Emergency Spillway.
Note: Emergency Spillway flows into wooded area to left in photo.

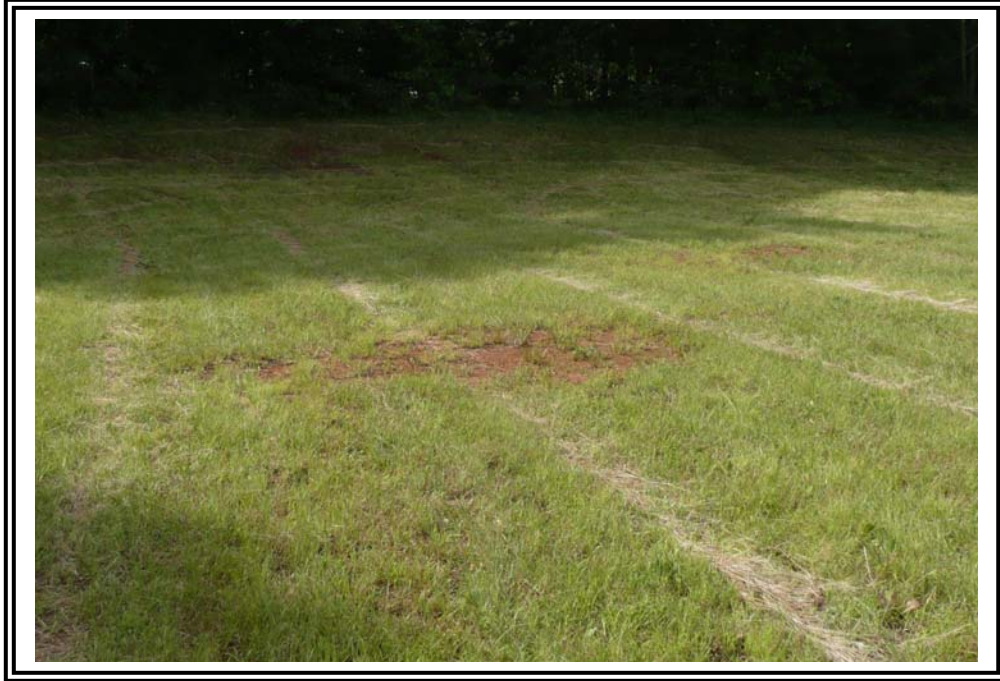
Sparse vegetation within Emergency Spillway.

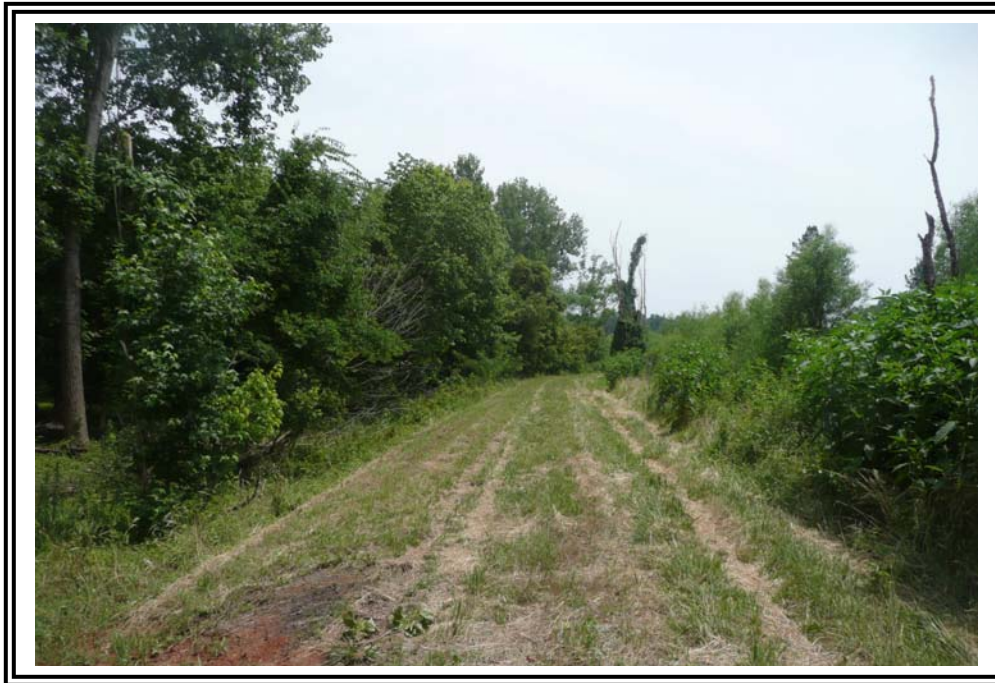
Dike through Basin 2 for access on inactive portion of Basin. Yard sumps discharged into channel in Basin 2 to right in photo, looking south.

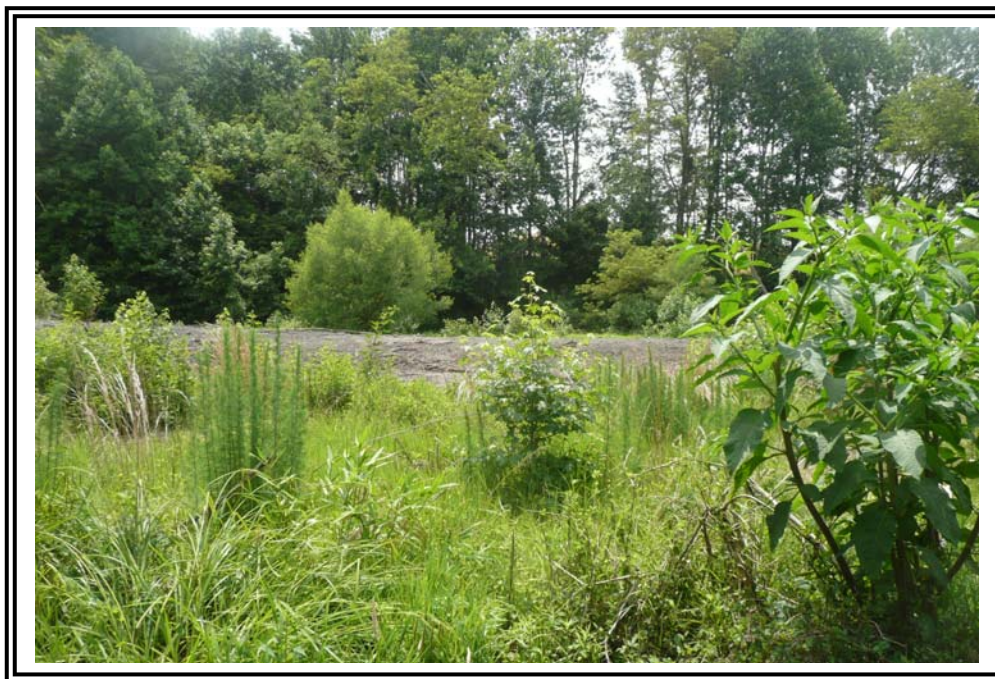
Ash Dike to control flows and prevent standing water in area of yard sump discharge.

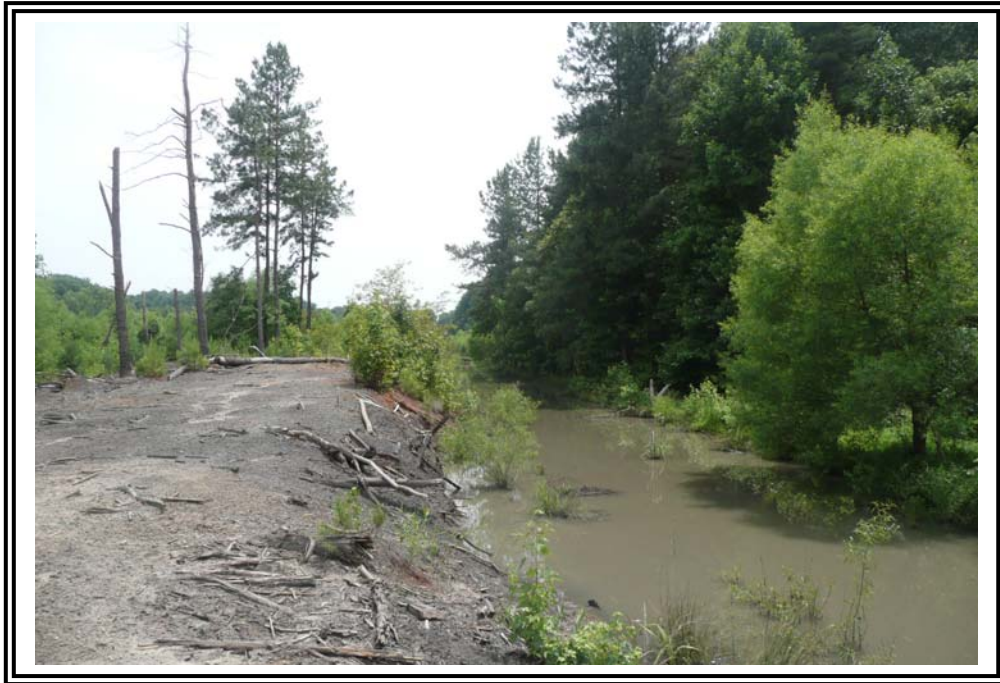
Ash Dike to control flows and prevent standing water in area of yard sump discharge.
